Fire Fighter Fatality Investigation and Prevention Program – Selected Investigation Reports

DHHS (NIOSH) Publication No. 2011-122
December 2010

Career Fire Fighter Dies When Backed Over While Spotting an Apparatus—New Jersey

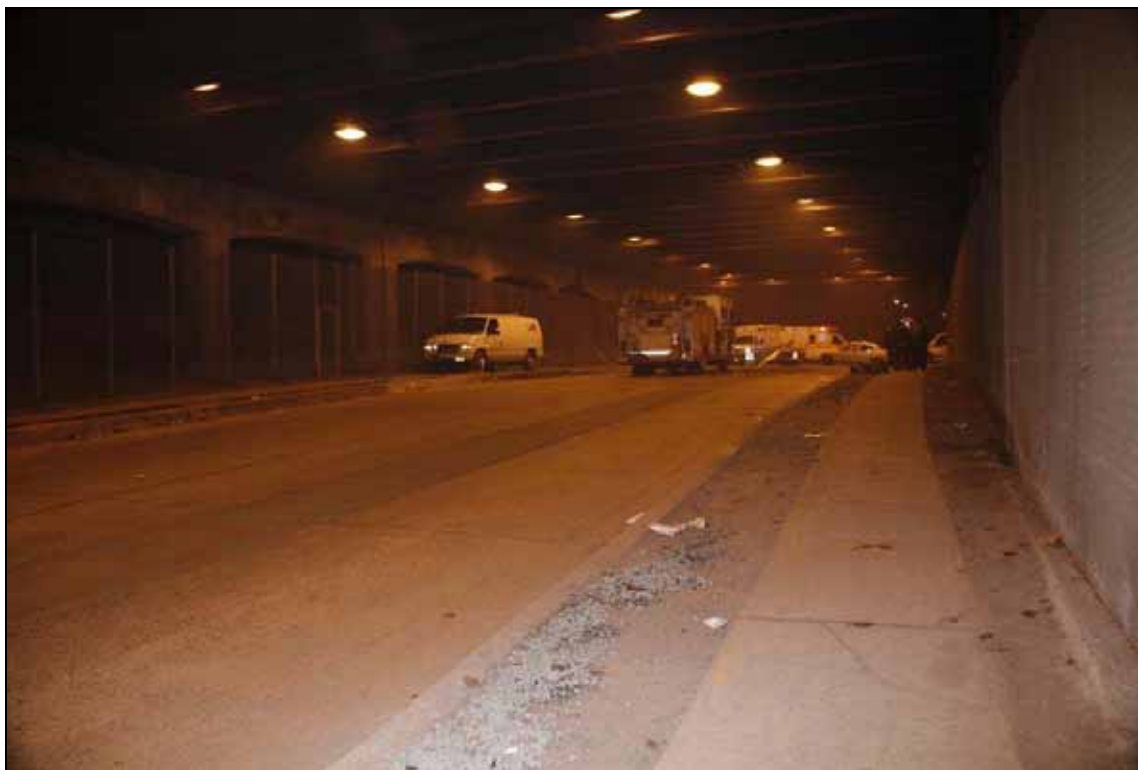
*Incident scene
(Photo courtesy of police department.)*

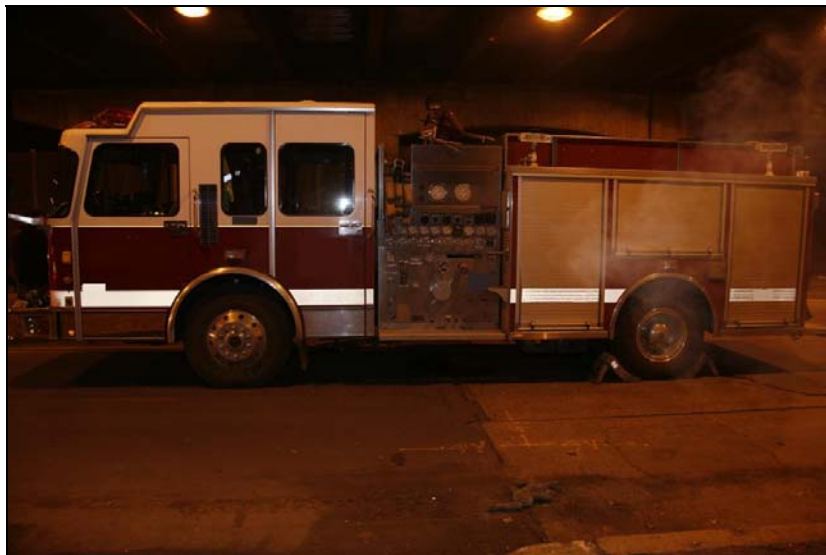
Photo 1. Apparatus involved in the backing incident.
(Photo courtesy of police department.)

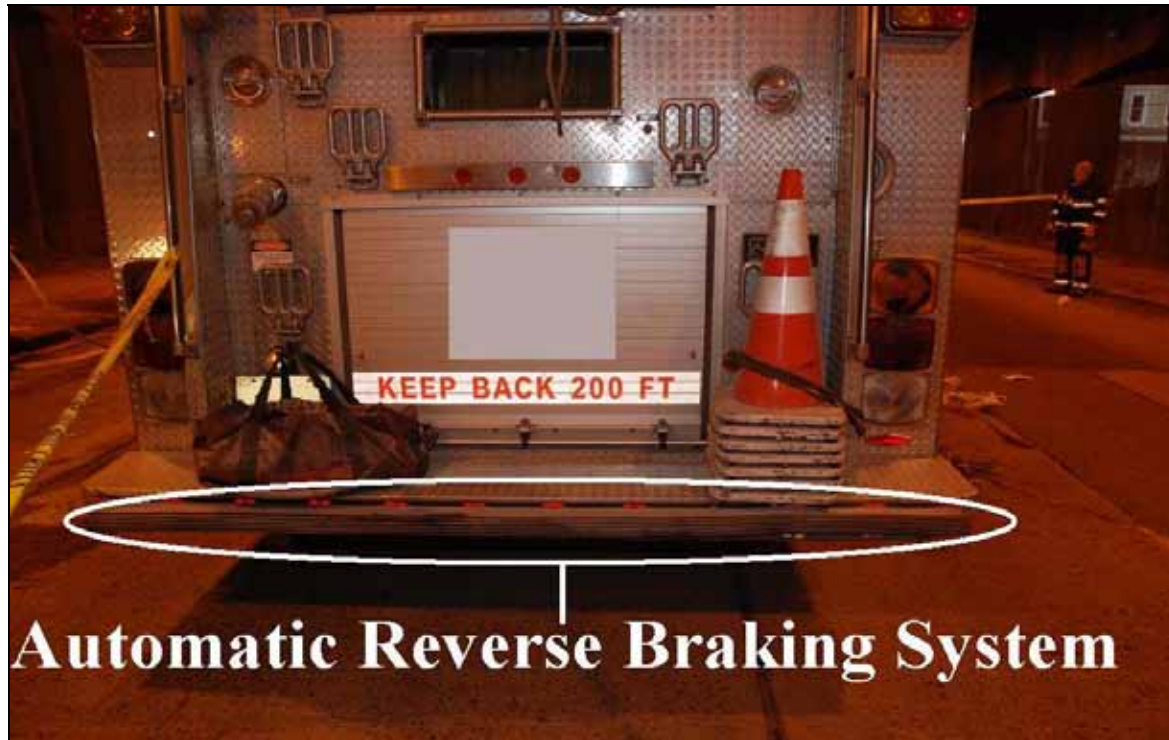
Photo 2. This reverse braking system is attached to the rear bumper of the apparatus and is designed to actuate the rear brakes when pressure is applied to the rubber sensor.
(Photo courtesy of sheriff's office.)

This automatic reverse braking system was developed in the early 1980s, introduced in the United Kingdom in 1983, and then became available in the United States in 1986. This reverse braking system was an optional safety feature that was installed on the apparatus prior to the fire department taking possession in 1996. The system aids driver/operators while backing an apparatus by locking the rear brakes when the system comes in contact with an object. *Note: The manufacturer's manual notes that this system does not exempt the driver/operator from using conventional backing aids such as side and rear mirrors or spotters.*³ The rubber sensor is mounted six inches beyond the vehicle's rear end to provide an area where vehicle damage could be reduced due to the short distance traveled after automatic brake application. The sensor has an air chamber which is sealed at either end. The air chamber detects or senses a compression of the wall of the chamber, as little as 0.05 psi, causing the pressure inside to increase and then transmit down to a control/switch unit which triggers the brakes to actuate. The system is designed to operate when the apparatus is in reverse gear and backing at a slow rate of speed. The instruction manual recommends a function test be done after initial installation and at least once a week thereafter. For the involved apparatus, the last documented function test was performed in March 2008; at that time, the system was working properly.

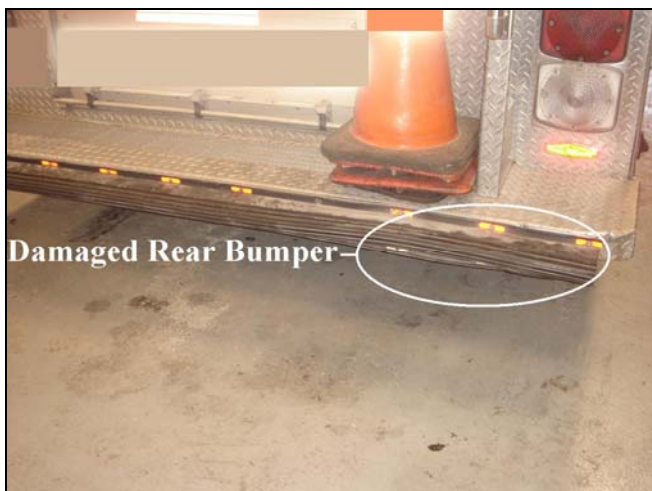
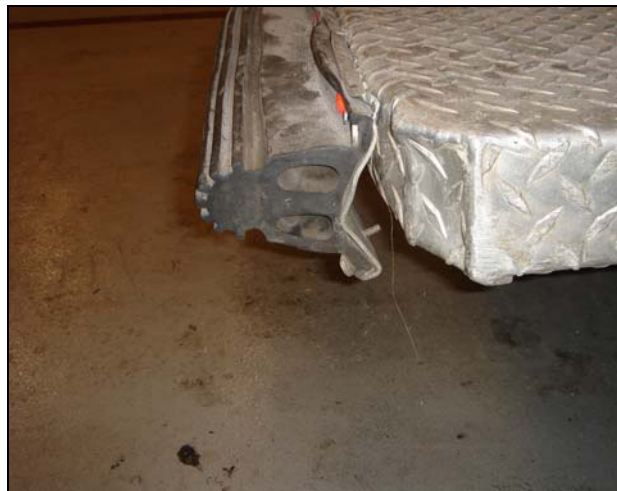
After the incident, the apparatus and scene were processed by local police before the apparatus was escorted by state police to the fire department's headquarters. The apparatus was secured there until state police could perform a vehicle inspection. The state police performed a standard commercial vehicle crash inspection in the presence of a fire department mechanic and investigators from the New Jersey Division of Fire Safety. Items inspected included the air brake system, brakes, steering, suspension, tires, lighting, and low air pressure indicators. The inspection was completed within three days of the incident and the apparatus was found to have no mechanical violations. The state police inspection did not include an inspection of the automatic reverse braking system because it was an optional device and their investigators were not certified to test it. However, when pressure was applied to the rubber sensor while backing, the system failed to actuate the brakes. It could not be determined whether the backing system was functional at the time of the incident, but there was damage to the bumper and rubber sensor that could not be attributed to the fatal incident (see Photos 3 and 4).

Photos 3 and 4. Pictures show damage to rear bumper and rubber sensor.
(Photo courtesy of PEOSH.)

From these findings, the New Jersey Division of Fire Safety recommended that repairs be made before placing the apparatus back in service. The automatic reverse braking system control unit was replaced following the inspection, and then placed back in service. The fire department also inspected eight other apparatus that had the same reverse braking system installed. Three of these apparatus had damaged or insufficient operating parts within the system that affected proper operation. These three systems were also repaired.

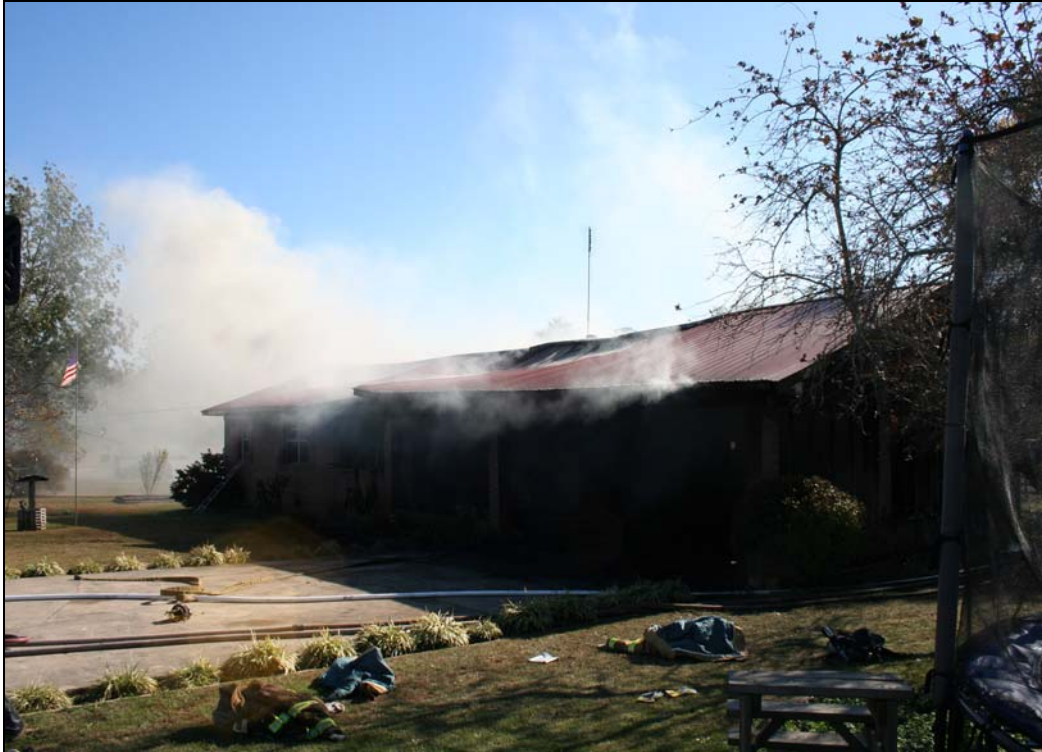
Incident Scene after Victim Removed
(Photo courtesy of sheriff's office)

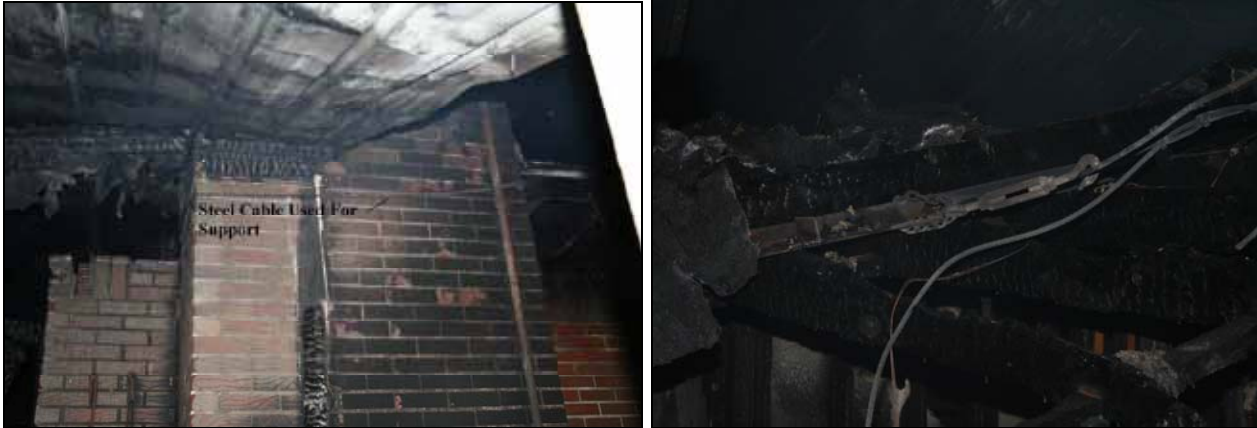
turnbuckle to connect the cable ends; this supported the chimney while pulling it back against the house (see Photo 1).

Photo 1. Steel cable used to support the chimney against the house with a turnbuckle.
(Photos courtesy of sheriff's office)

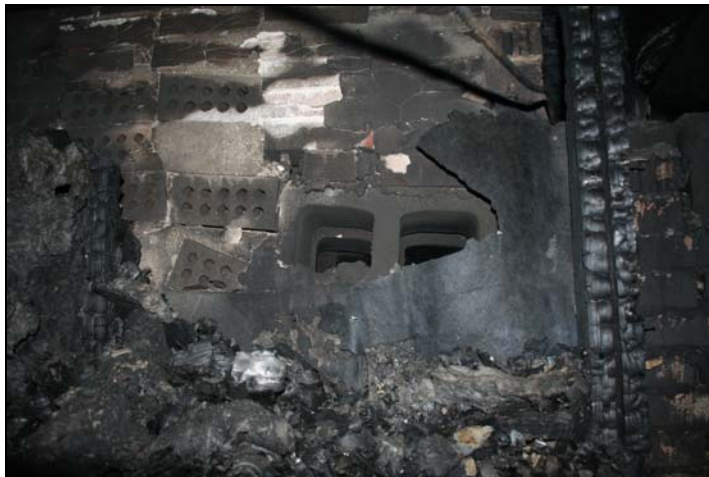
After the chimney was repositioned, the owner noticed that bricks from the chimney's flue had cracked and shifted. The owner removed the damaged bricks and replaced them with hollow cinder blocks. These blocks had been laid with the hollows horizontally positioned towards the attic space (see Photo 2). The residents of the house were safely evacuated prior to the fire department's arrival. The structure was completely destroyed by a rekindle several days later.

Photo 2. The picture shows the area of the brick chimney flue that was replaced with cinder blocks. The cinder blocks allowed heat and flame to impinge on the exterior wall allowing fire to spread into the attic space.
(Photo courtesy of sheriff's office)

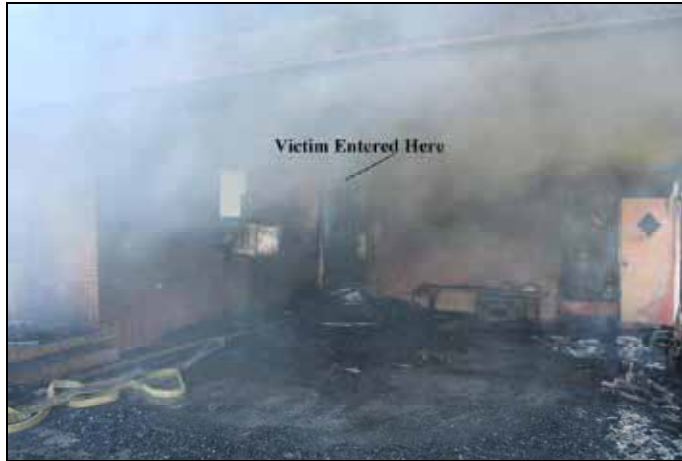
Photo 3. Door under carport that victim entered through.
(Photo courtesy of sheriff's office)

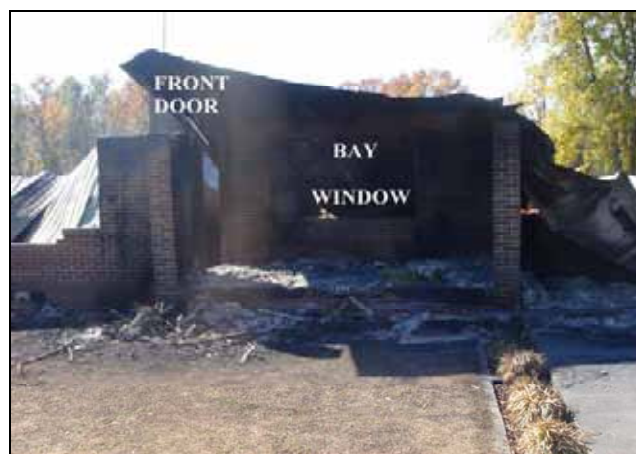
Photo 4. Incident scene after rekindle and collapse showing the front door and bay window.
(NIOSH photo)

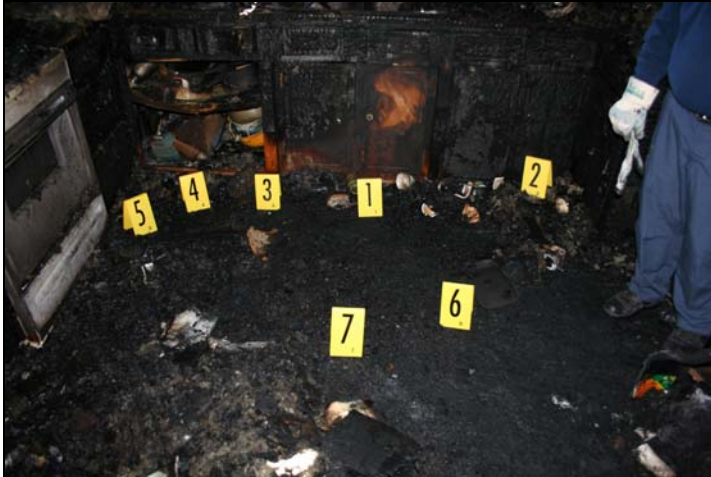
| <ol style="list-style-type: none">1. Victim – 112” from carport door2. SCBA – 85” from carport door3. Face Piece – 128” from carport door4. Helmet – 139 ½” from carport door5. Radio – 147” from carport door6. Boot – 94” from carport door7. Nozzle – 101” from carport door |

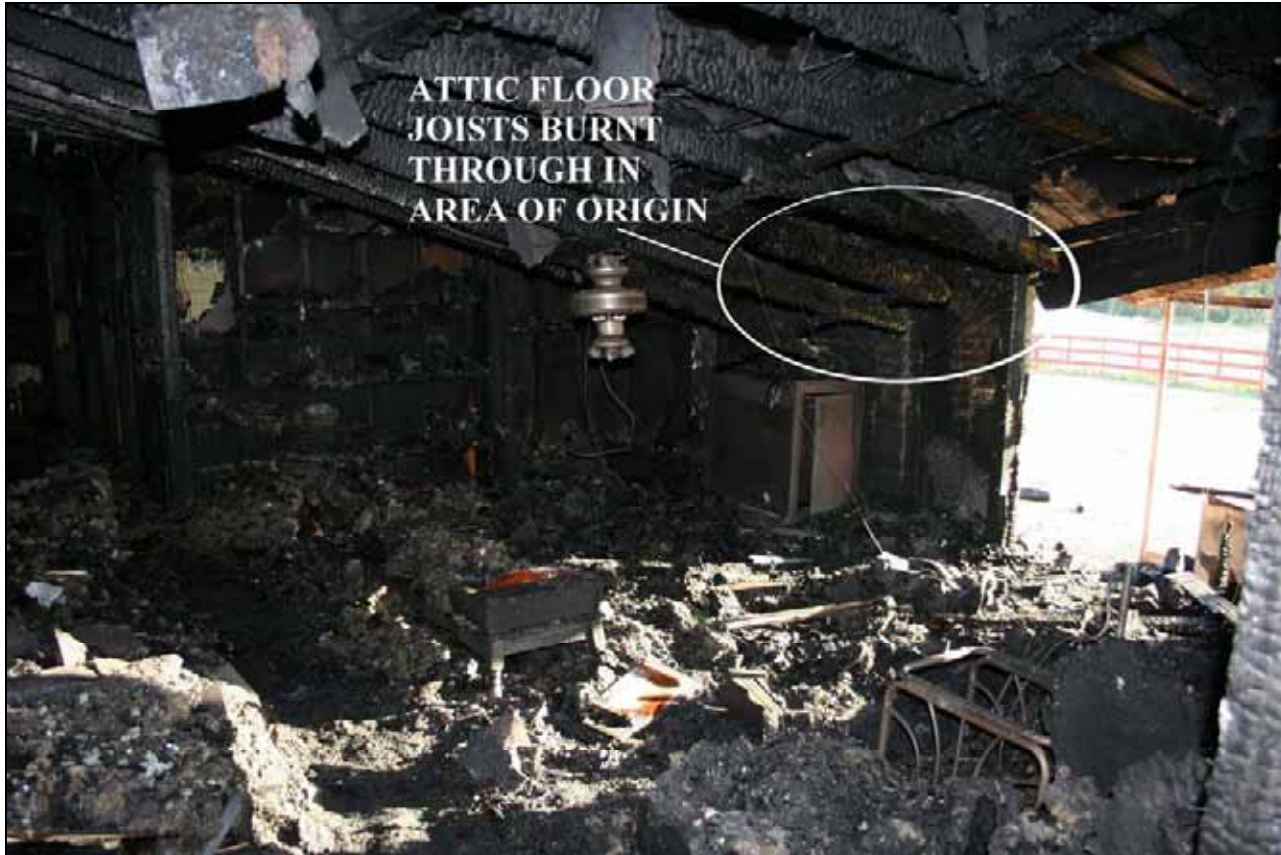
Photo 6. Fire damage to living room area before rekindle and structural collapse.
(Photo courtesy of sheriff's office)

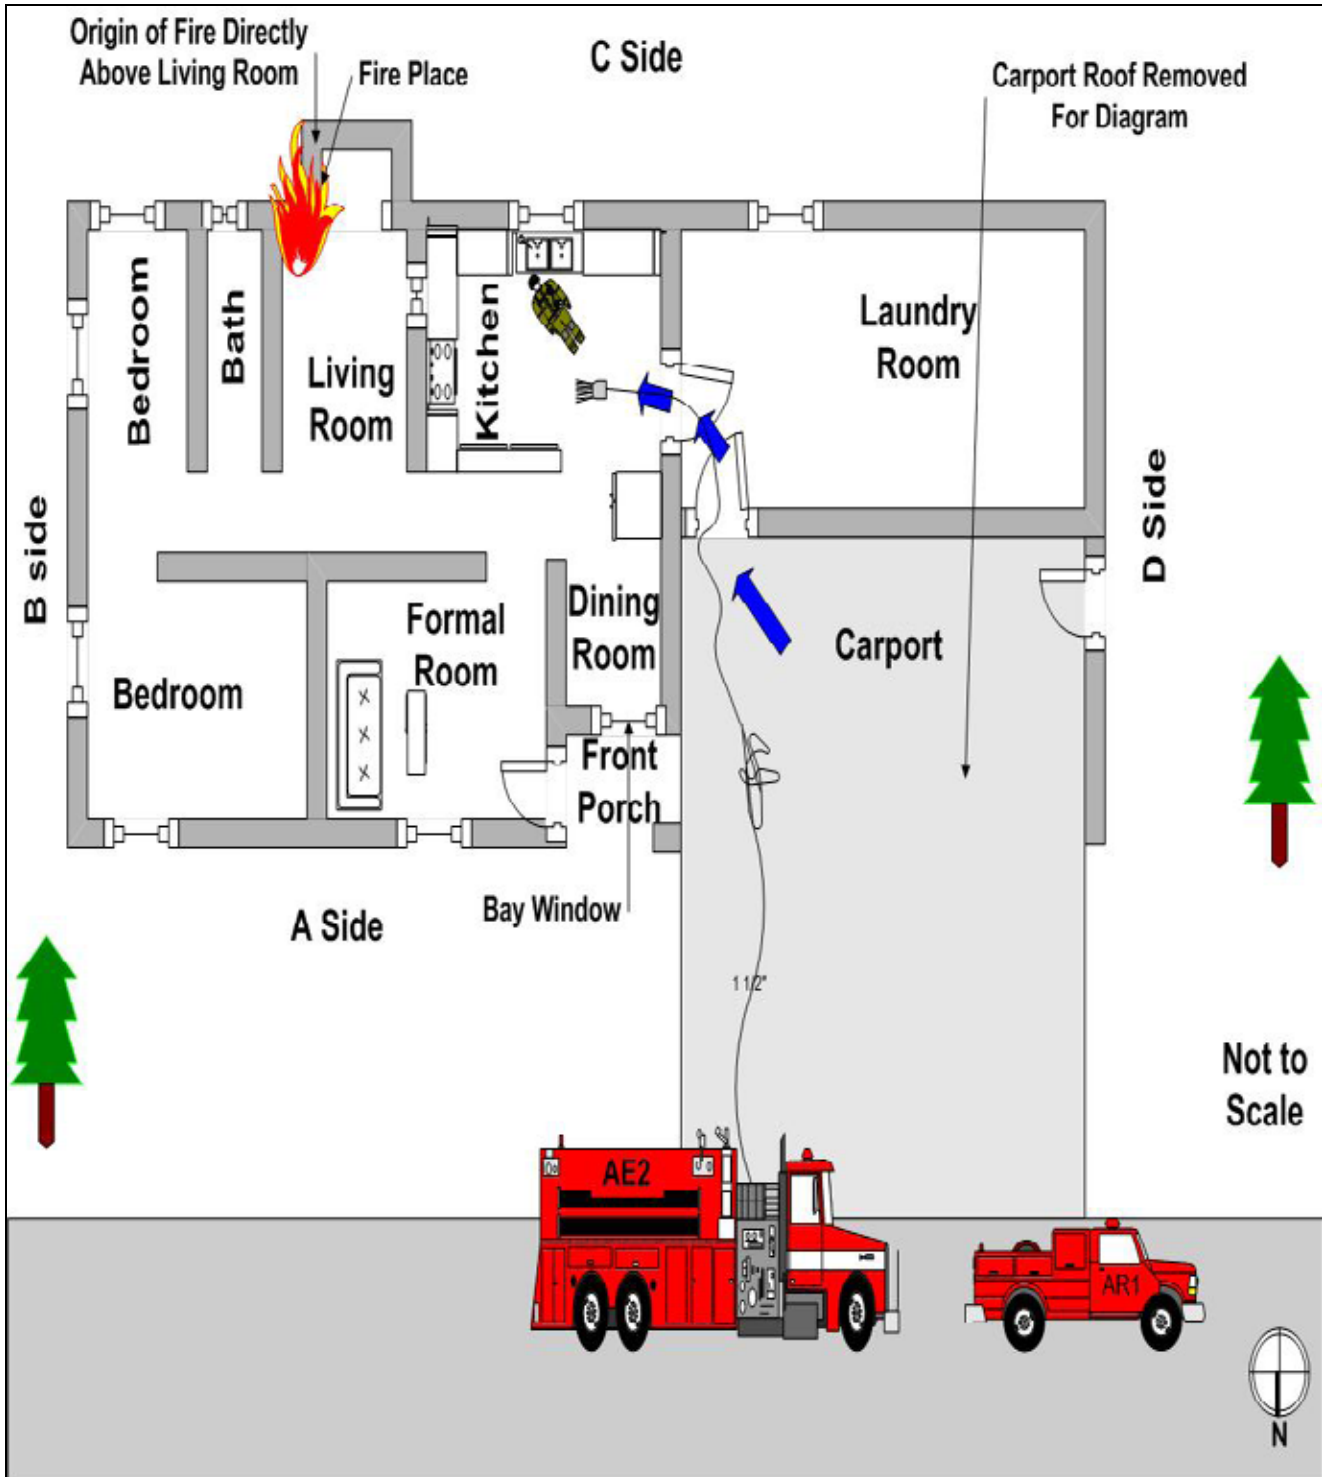
Diagram. Incident scene when victim called for help.

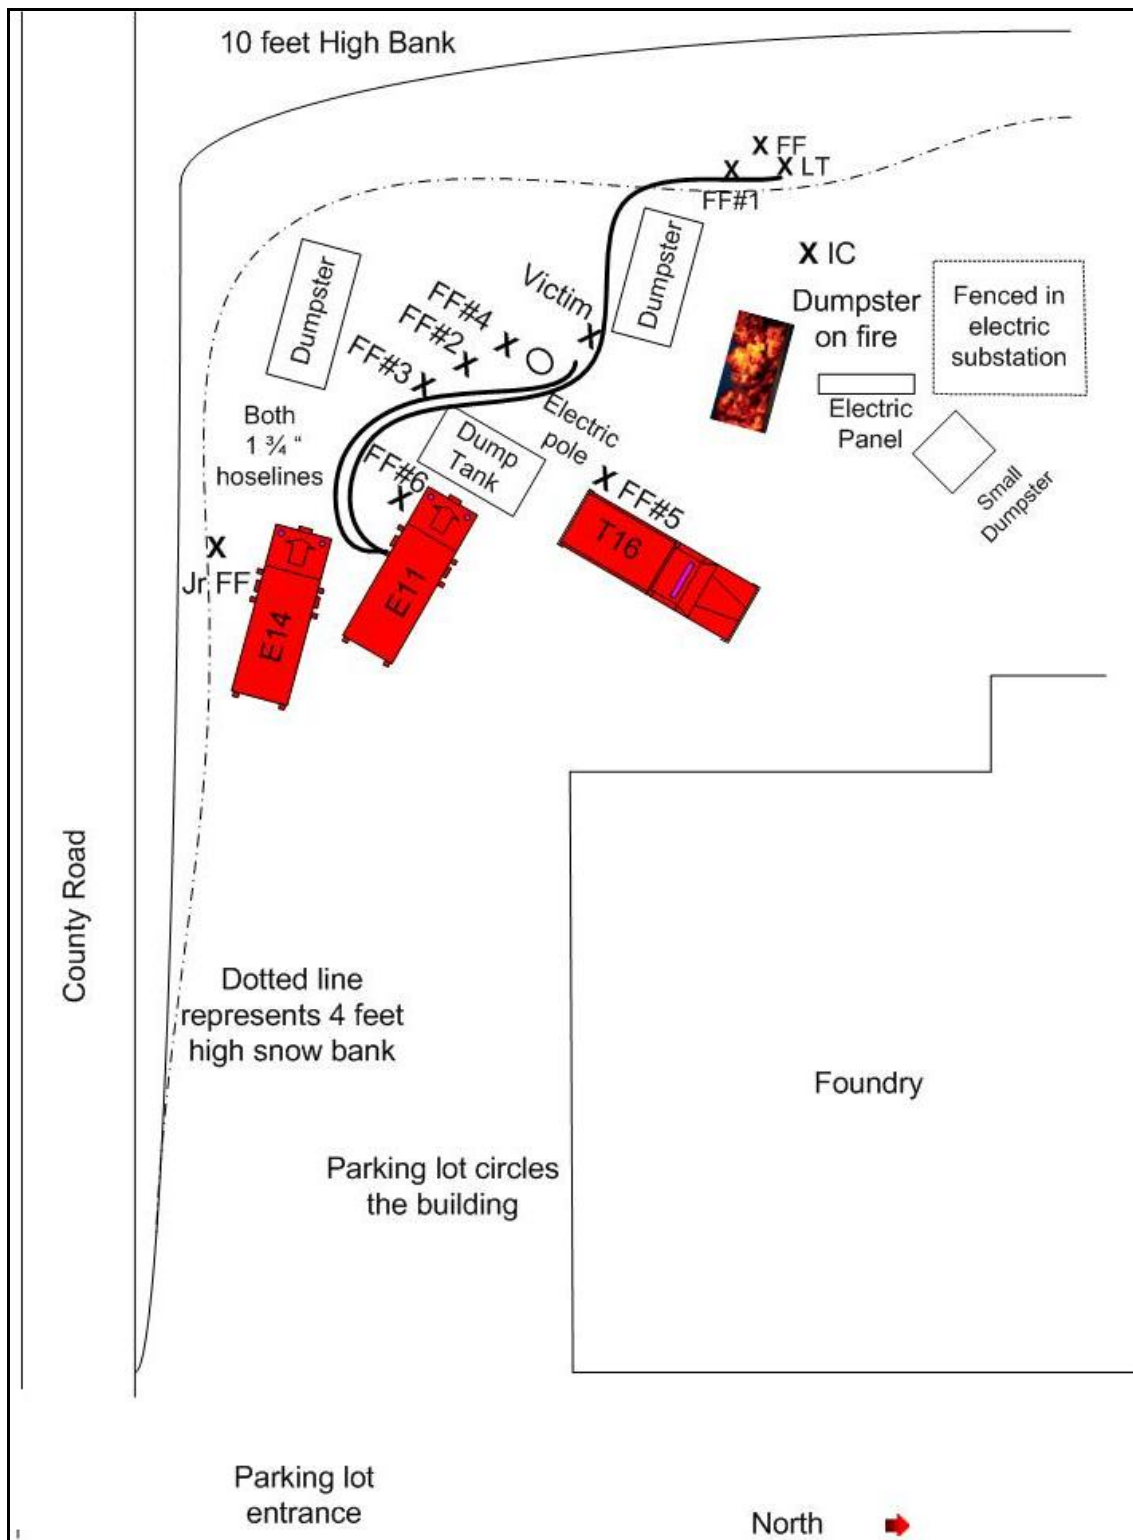
Diagram 1. Approximate locations of key apparatus and personnel just prior to the explosion.

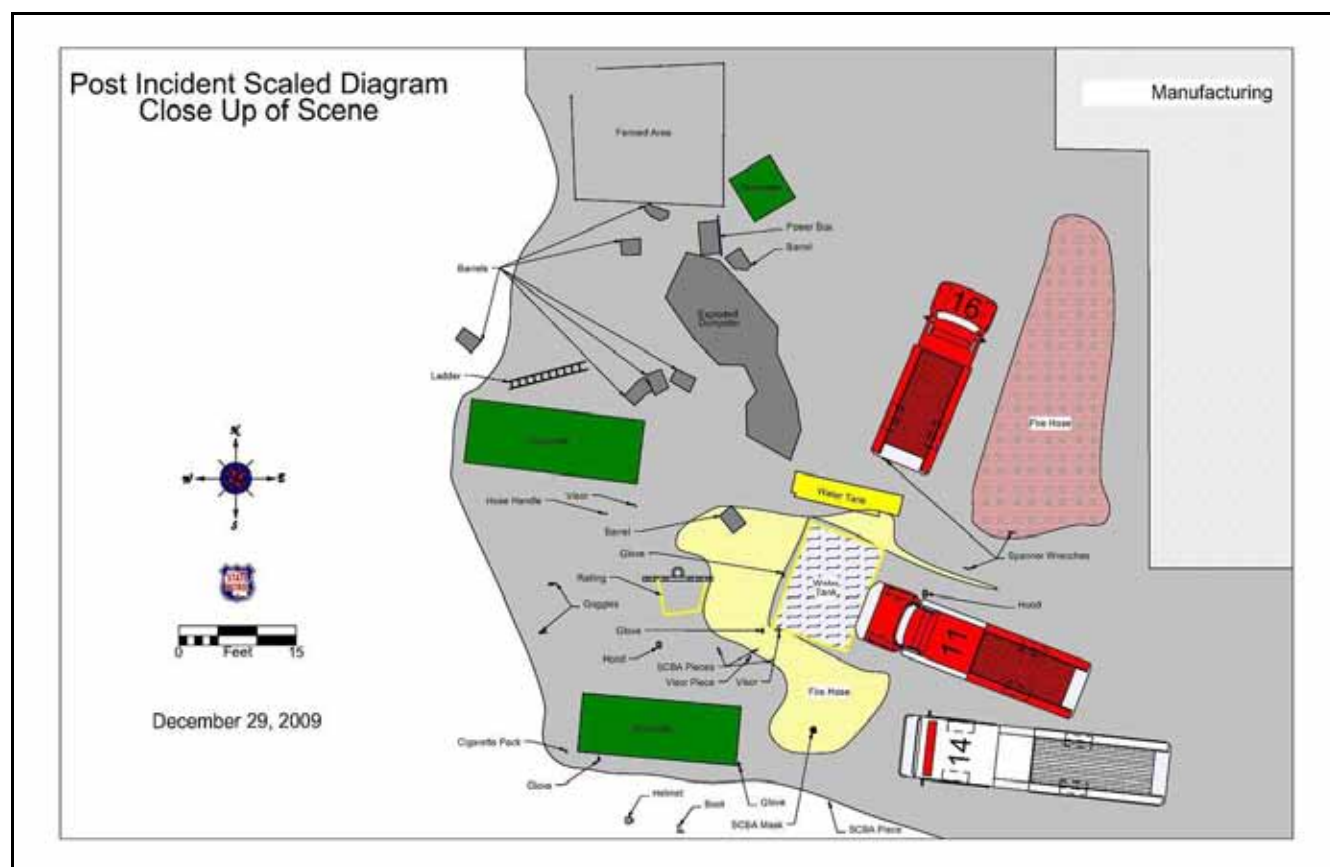
Diagram 3. Post incident scaled close-up of the scene.
(Courtesy of the Sheriff's Department)

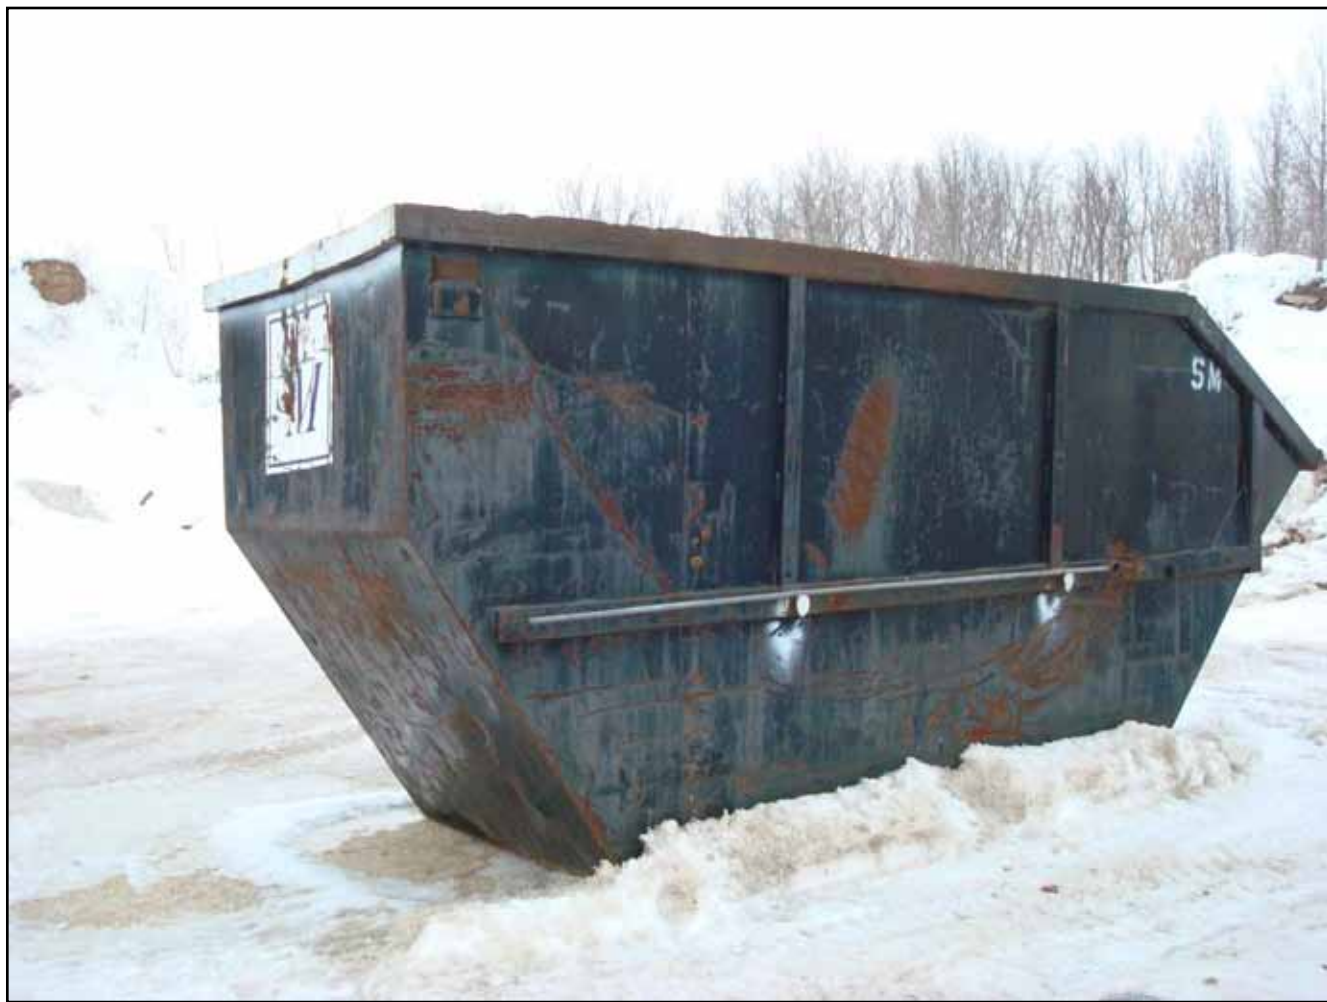
Photo 1. A dumpster similar in size and shape to the one that exploded. (*NIOSH photo*)

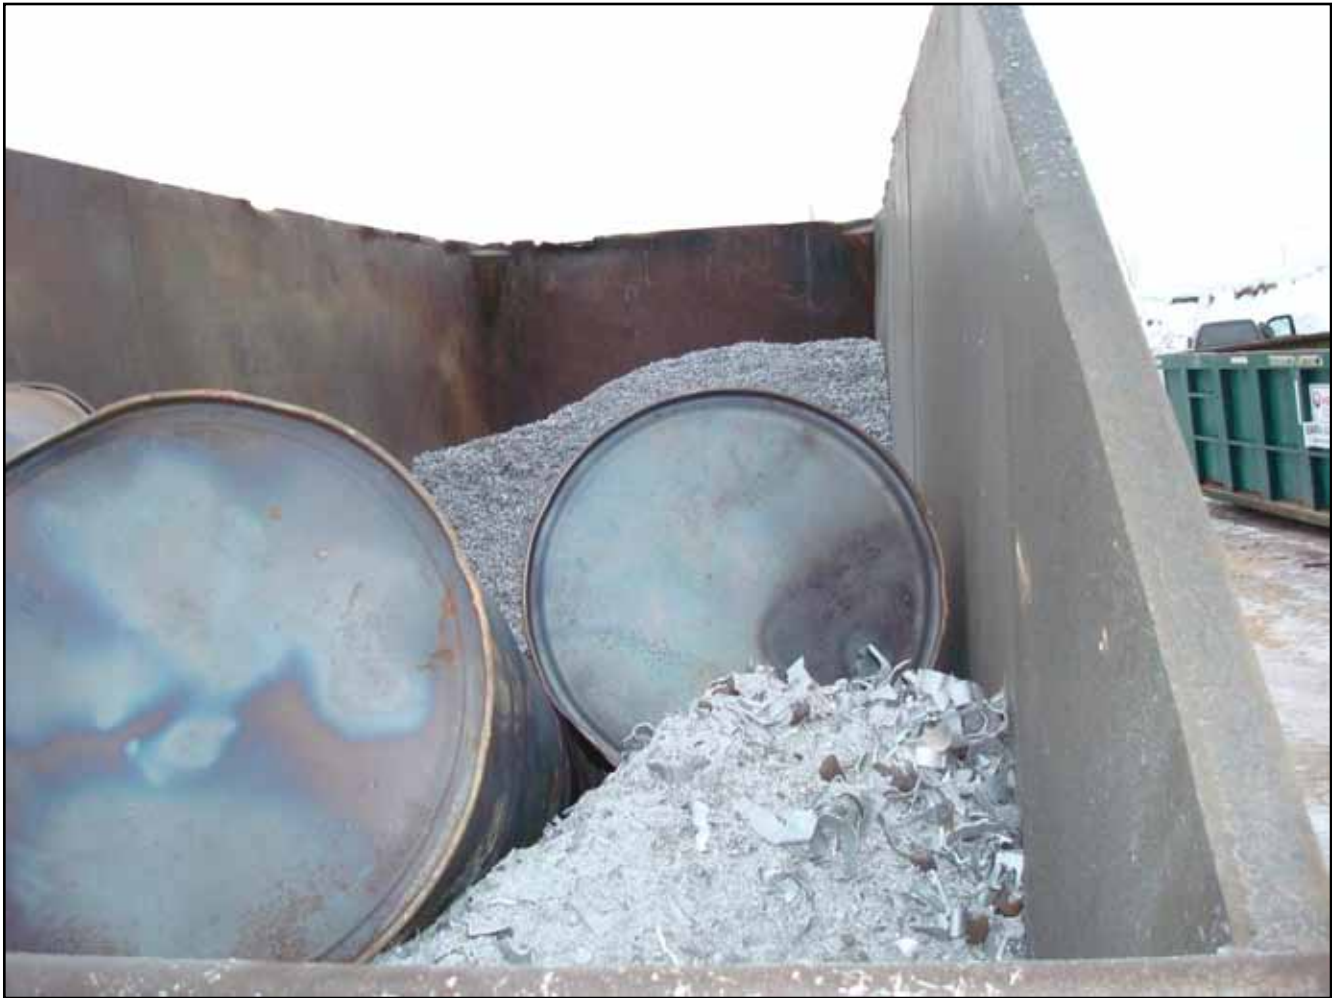
Photo 2. Dumpster contents similar to the contents of the dumpster that exploded. Note thermal pattern and iron oxide (rust) on slag barrels.
(NIOSH photo)

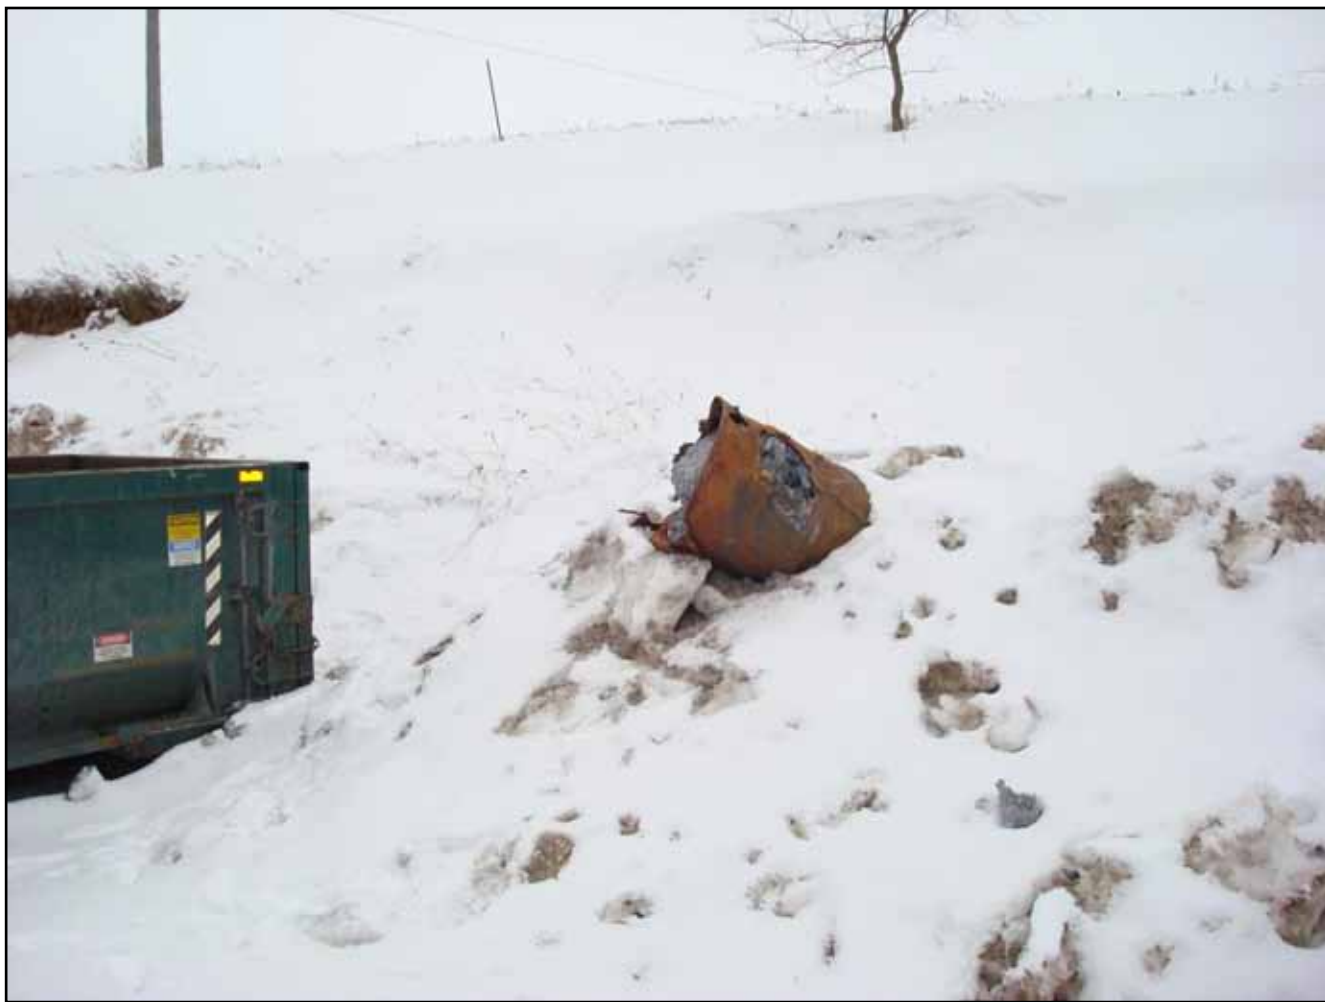
Photo 3. Barrel that was blown from the dumpster and believed to have impacted the lieutenant who had been standing at that spot on the snow bank with the 1 $\frac{3}{4}$ " hoseline.
(NIOSH photo)

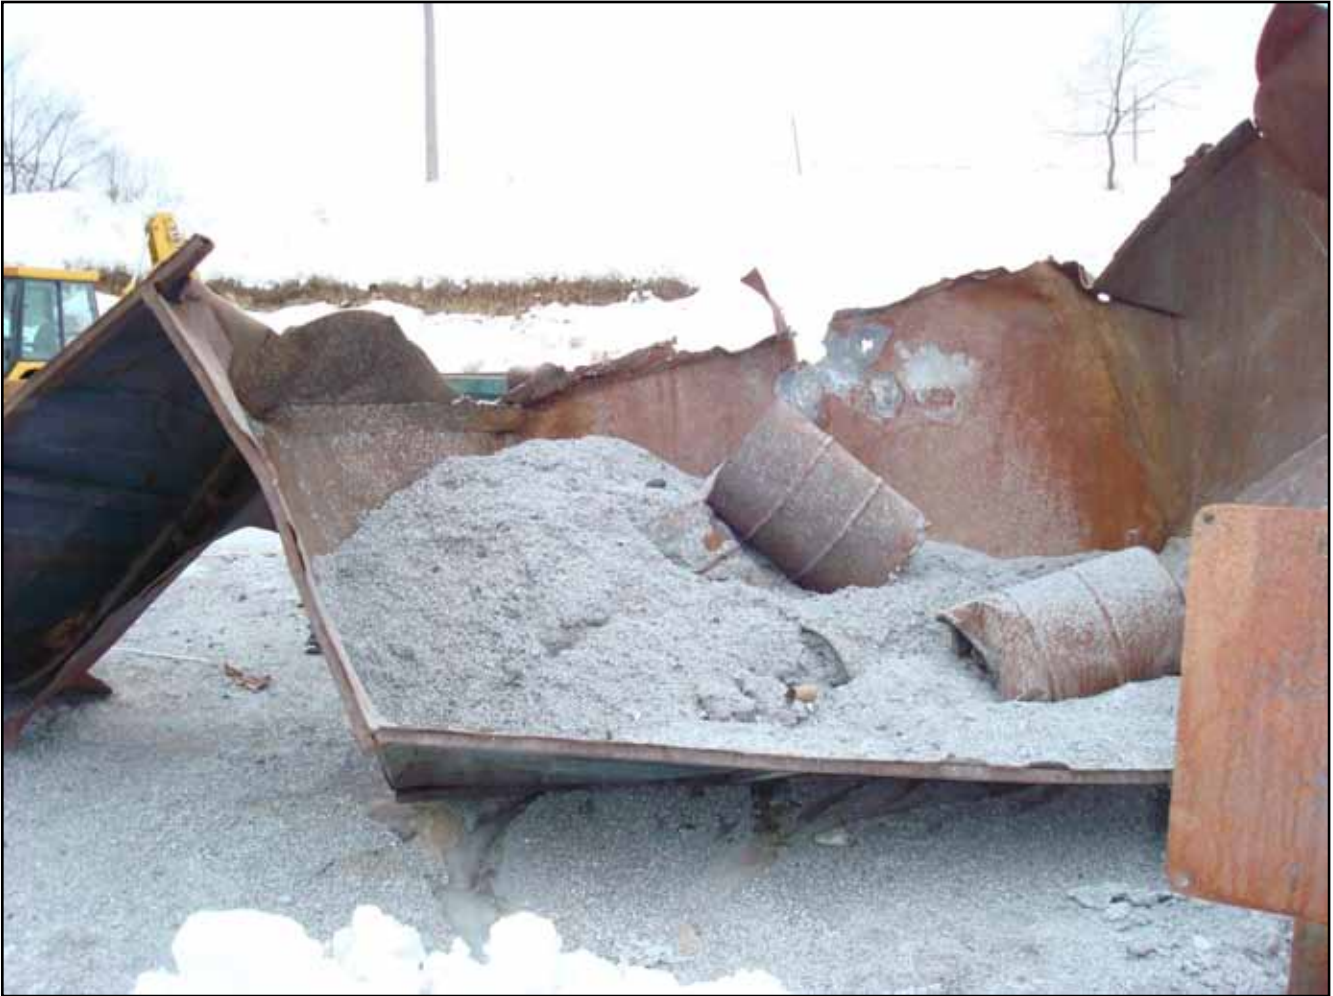
Photo 4. Exploded dumpster and its' remaining contents. *(NIOSH photo)*

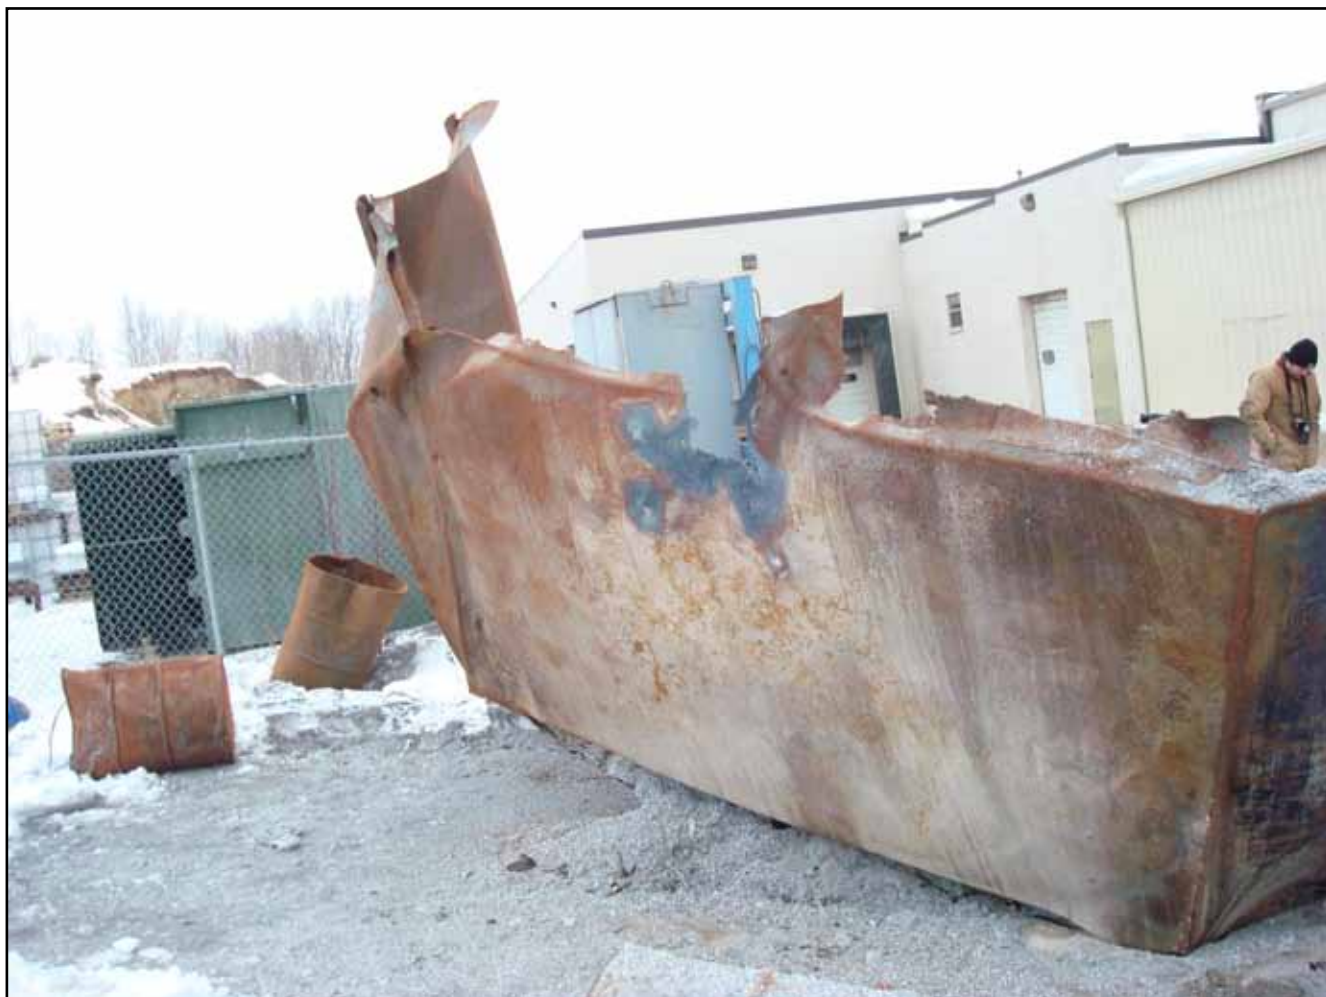
Photo 5. Bottom of the dumpster showing the origin of the fire in the dumpster.
